BERW ROAD BRIDGE, PONTYPRIDD

Steve Jones of **Concrete Repairs Ltd (CRL)** discusses the challenging repair project to the White Bridge, a historic structure in south Wales. The bridge needed thorough structural surveying, careful gunite and reinforcement repair, and a design life extension of 50–60 years.

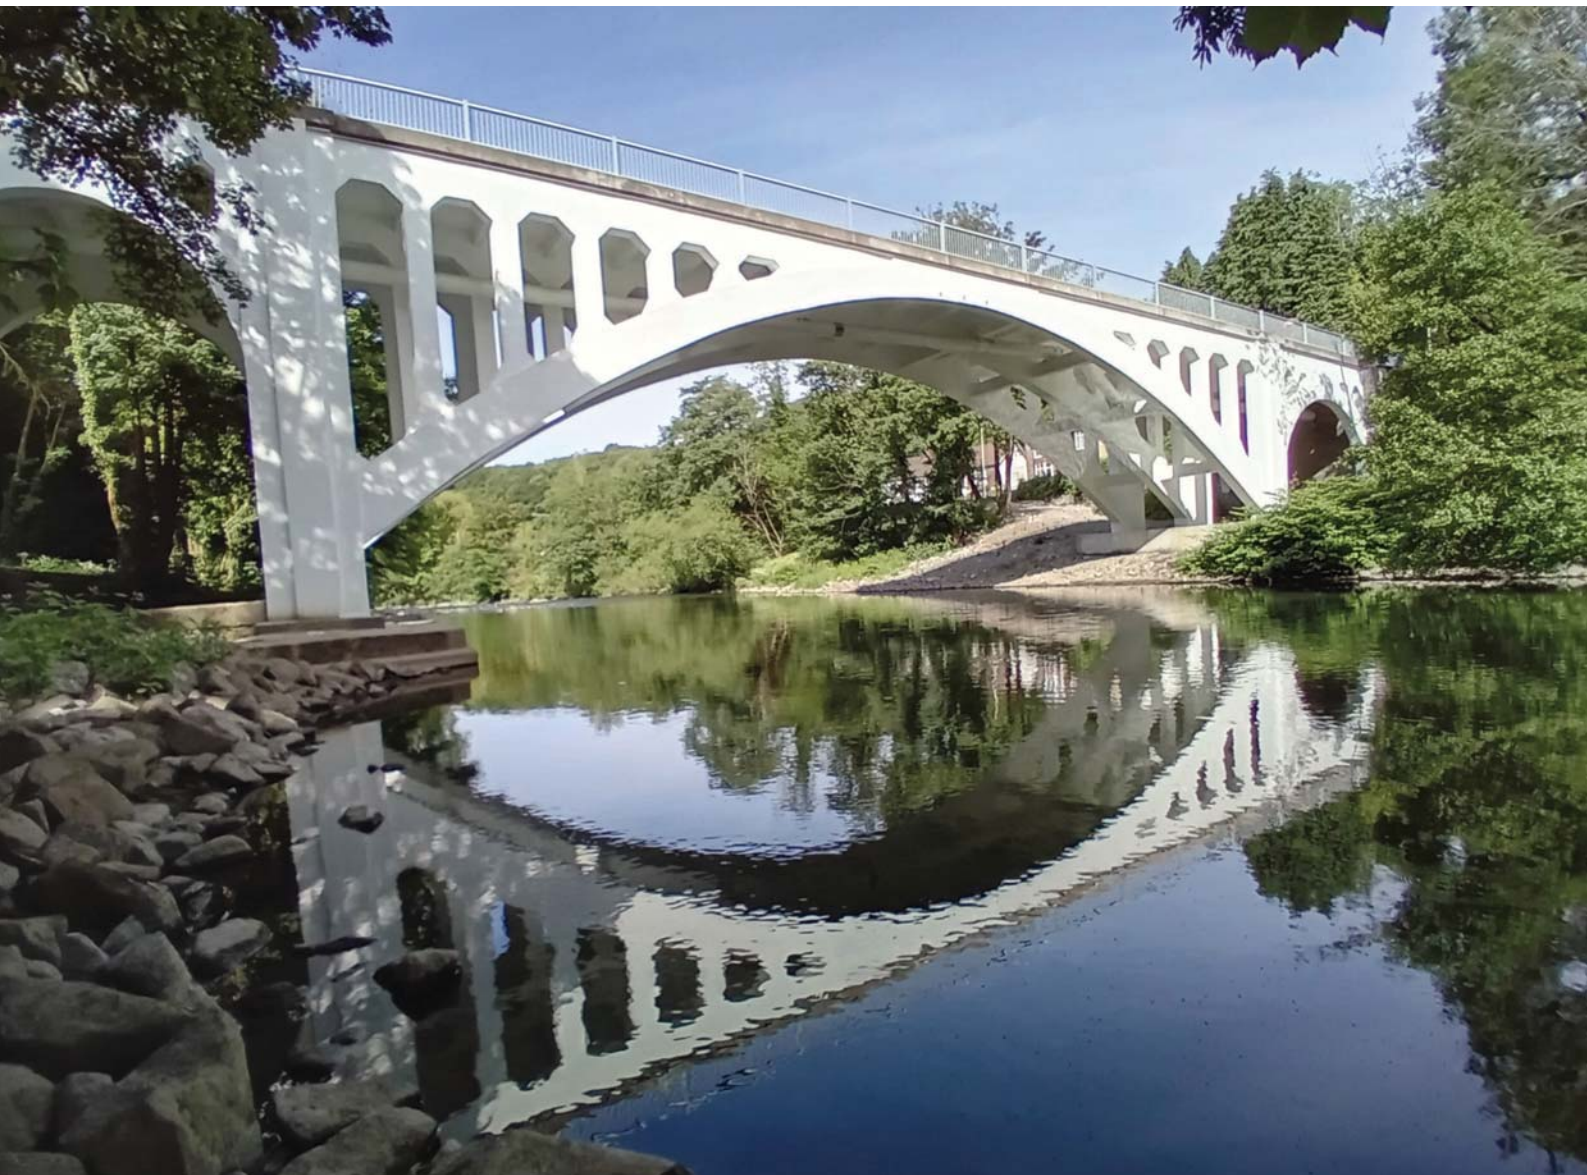
MAIN IMAGE, OPPOSITE PAGE:

Berw Road Bridge following completion of repairs in July 2024.

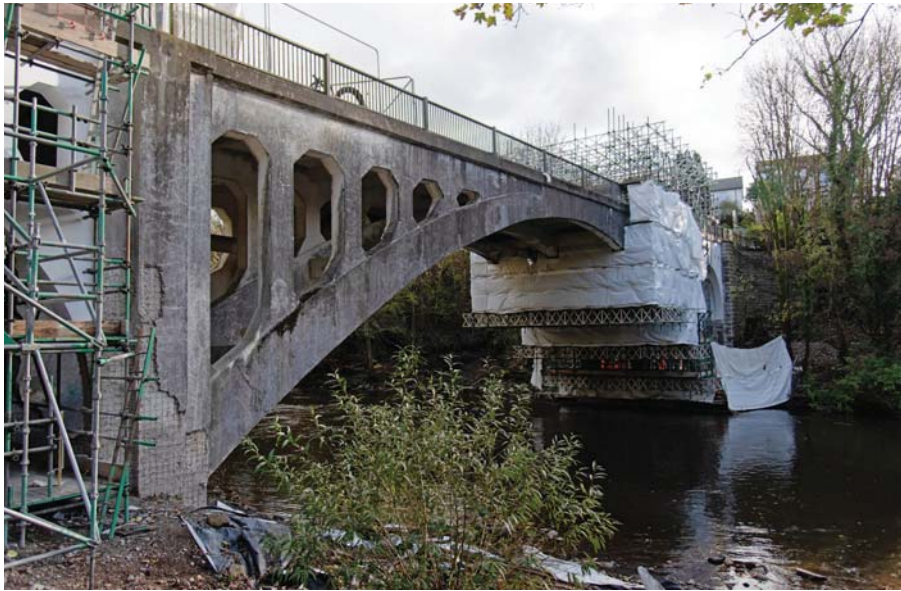
ABOVE:

State of the bridge at the commencement of repair works.

CRL Surveys carried out a structural survey of the bridge, including reinforcement make-up and condition of the underlying concrete. Checks were also conducted on the condition of the existing gunite layer applied in the 1960s. It was found that approximately 60–70% of the gunite was delaminated. WSP’s structural assessment report confirmed the overall load rating for the bridge to be 7.5 tonnes and repairs needed to be undertaken to maintain the integrity of the bridge.

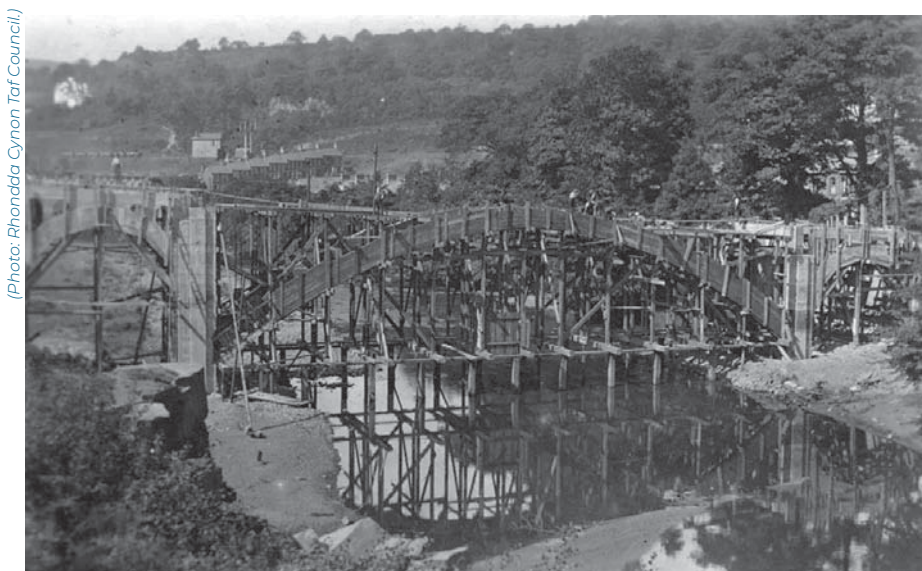
LEFT:

Construction of the original bridge in 1908.

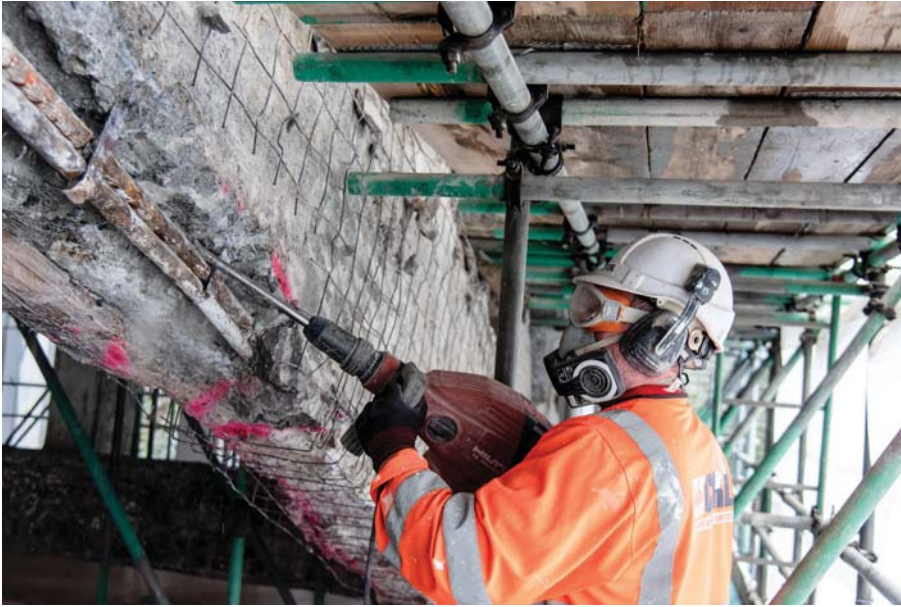
FAR LEFT:

Repairs were largely broken out by hand breakers.

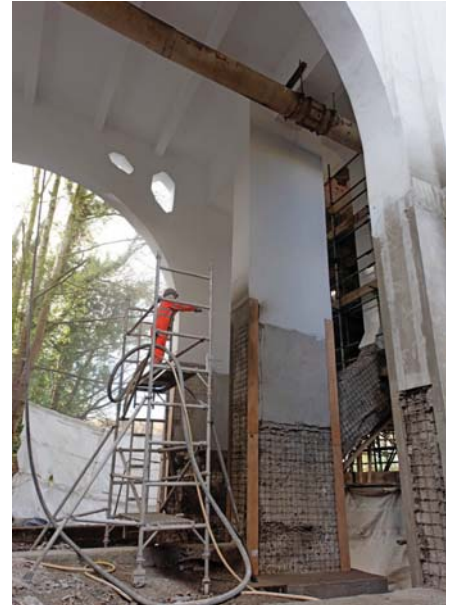
ABOVE MIDDLE:
Guniting was removed and new reinforcement fabric fixed to the substrate.

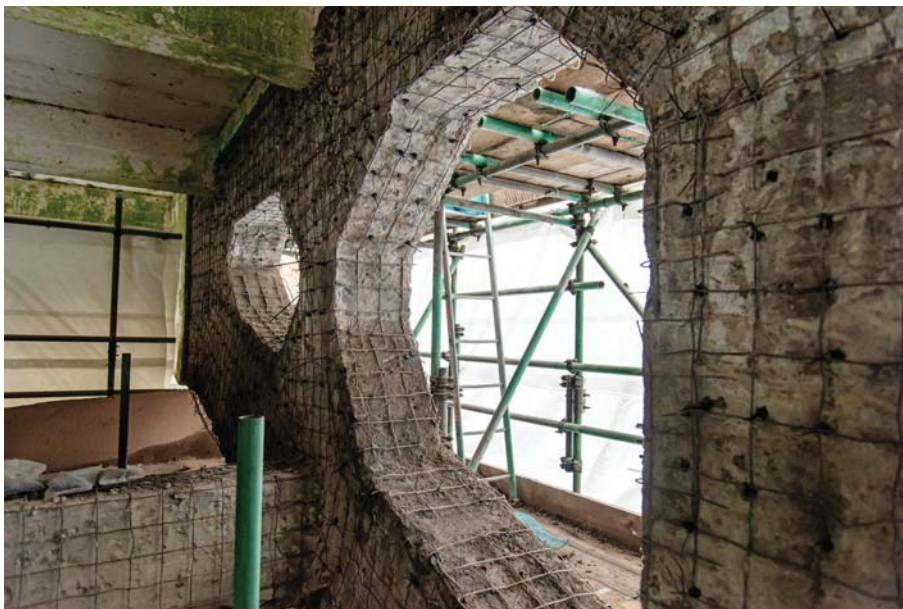
ABOVE:
Coating the reinforcement.

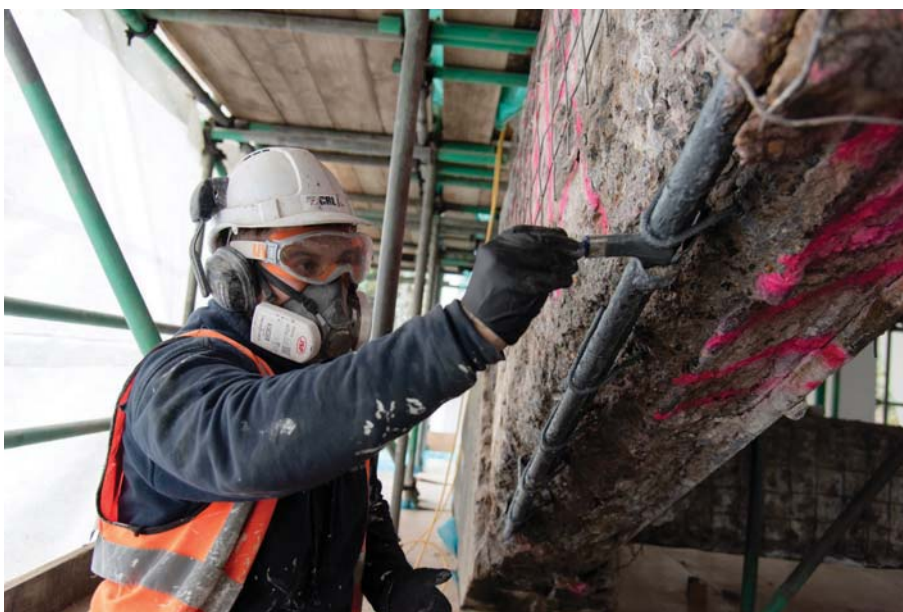
LEFT:

Anti-carbonation coating being spray applied.

Finally, the concrete structure was coated in Fosroc Dekguard A Plus anti-carbonation coating to restore the Berw Road Bridge ('White Bridge') to its original colour and former glory.

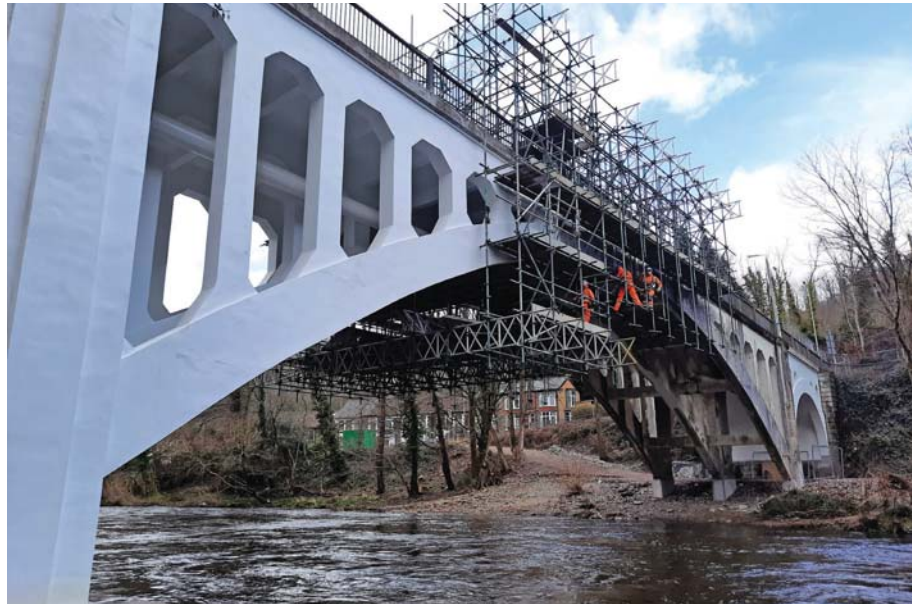
RIGHT:

A suspended scaffold system was required to carry out the works.

A designed scaffold, which was required to be undertaken under a flood risk activity permit (FRAP) agreement, was needed to provide access to the various areas of the structure where repair works had to be carried out. This meant the scaffold had to be kept out of the river, necessitating a suspended solution supported by the unrepaired arch. Fortunately, some ground support for the scaffolding

was possible at either end of the bridge on the pier foundation bases. These were used to support the scaffold bases and the unsupported sections were then cantilevered out to obtain maximum coverage. This still left three middle sections that needed to be fully suspended from the bridge. Crouch Waterfall undertook the assessment, working with PSS Scaffolding and its designer TAD Scaffold Engineering to produce an acceptable design.
