CLEVELAND BRIDGE, BATH

With the emphasis in construction on sustainability and carbon reduction, the repair of historic and listed concrete is becoming increasingly common to not only keep these structures in use but also bring them up to modern-day standards. Jon Bradshaw of Concrete Repairs Limited reports on the works being carried out to the Grade II-listed Cleveland Bridge in Bath.

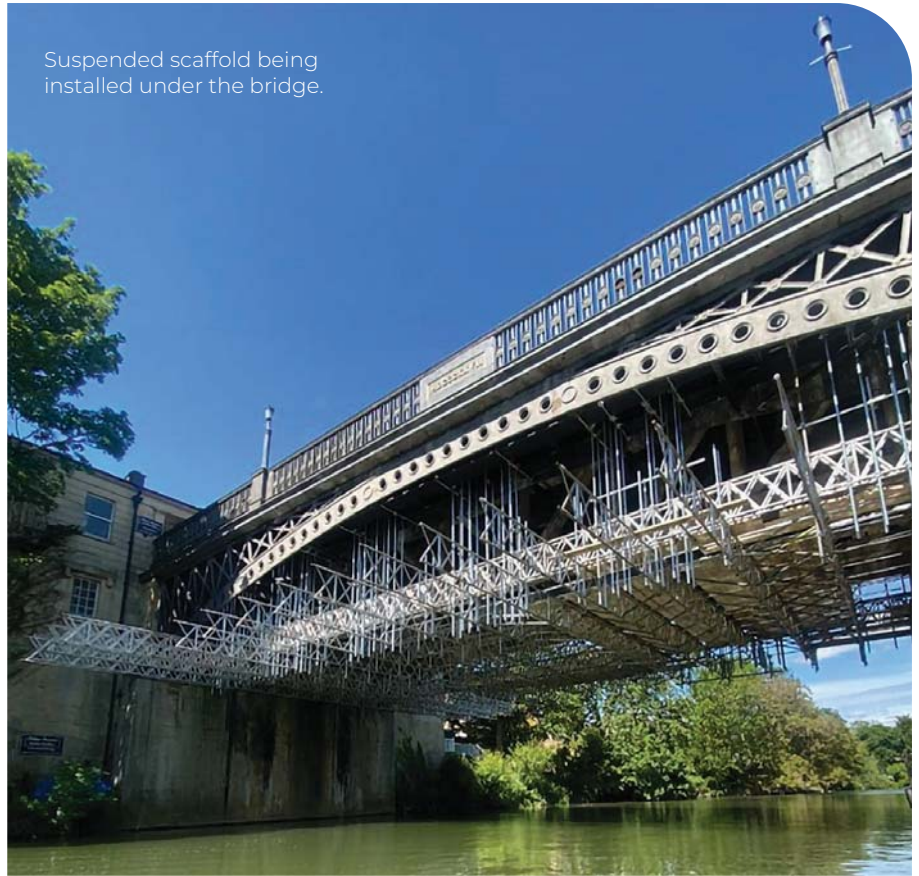
Suspended scaffold being installed under the bridge.

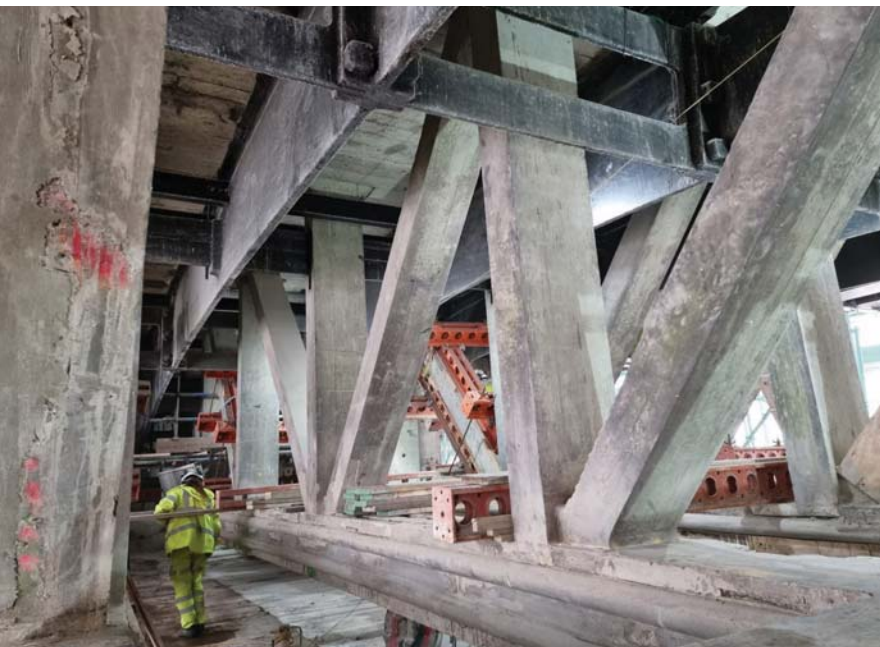
TOP LEFT:

View of concrete trusses and cast-iron arches under the bridge.

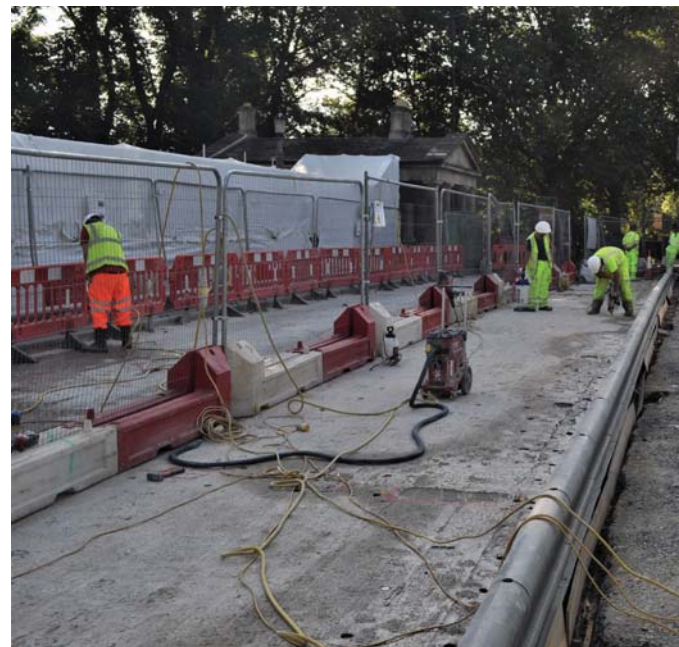
ABOVE:

View of bridge deck with hybrid anodes being installed.

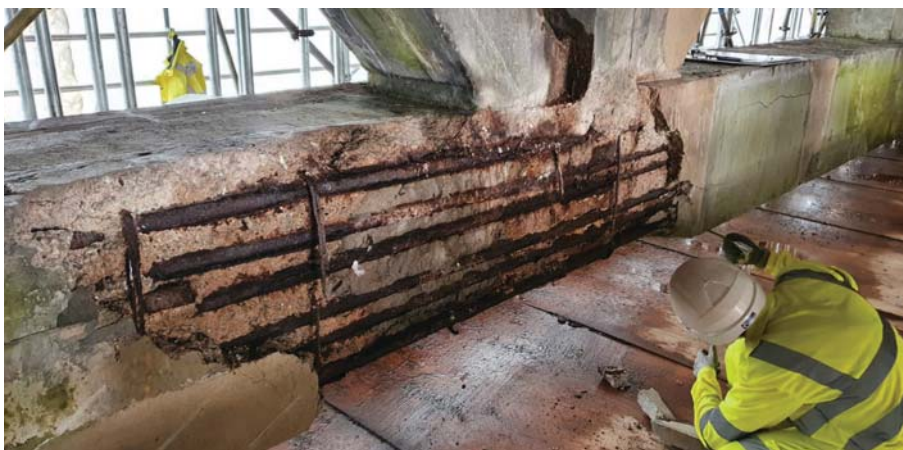
LEFT:

Typical condition of a concrete truss prior to repairs.

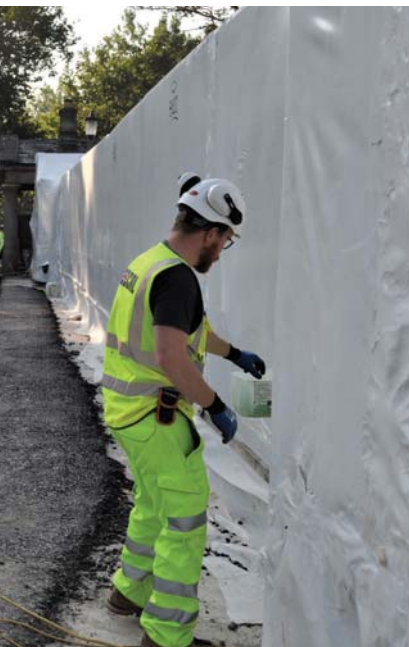
TOP RIGHT:

The works have not been without their issues, with the biggest change being the increase in the quantity and size of the concrete repairs required – from 4 to 10m³. As the amount of concrete that was needed to be broken out in individual patches increased by such a large amount, it became necessary to install a system of temporary propping to support the individual elements as they underwent repairs. Designs were needed for each set of temporary works and, coupled with their installation, this increased the duration of the works significantly.

Temporary works required around repaired areas.

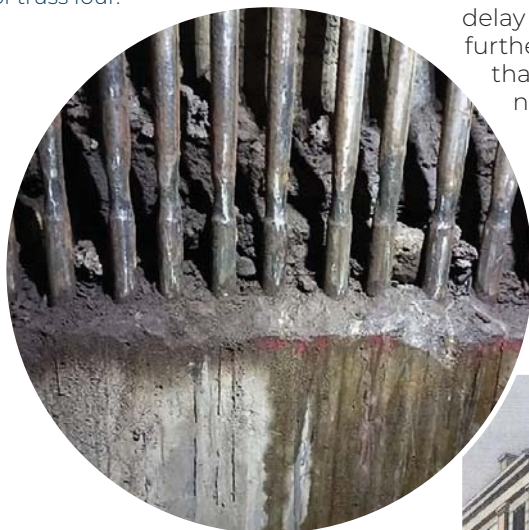
INSET:

Corrosion on the hanger bars at the north end of truss four.

Even at this late stage of the project, new issues are coming to light that couldn't have been foreseen at tender stage and are still likely to delay the full opening of the bridge further. It was recently discovered that the hanger bars at the north end of one of the trusses have suffered significant and severe corrosion, estimated to be approximately 40% of their cross-sectional area. This could pose a serious enough risk of structural failure of the bridge were it to reopen to all vehicles

before some form of repair is carried out. Hanger bars are not a commonly used engineering solution in bridges and deciding how to repair these corroded hangers is proving to be a technical challenge. Various options are being explored, with the current proposed plan being to place a bearing underneath the trusses to take the bridge loading.
