Redbridge Viaduct

Steve Jones of Concrete Repairs Ltd (CRL) looks at current repair works undertaken to Redbridge Viaduct in southern England.

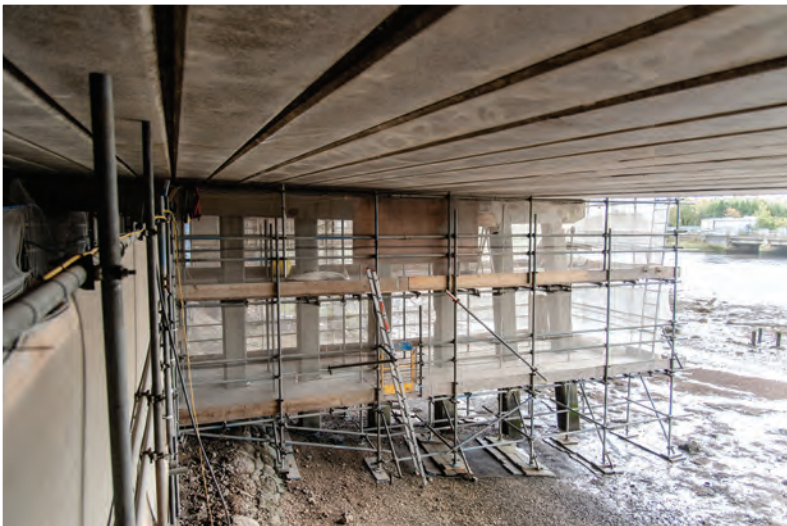
Scaffolding column bent at low tide.
