# Protecting our assets: the Woolwich Ferry jetties

**The Woolwich Ferry is a free service operating between Woolwich and North Woolwich, linking the north and south circular roads across the Thames. It is a vital, heavily used service that relies on the concrete approach viaducts (jetties) for the loading and unloading of the cars and trucks using the ferries. In 2013, a contract was awarded to Concrete Repairs Limited (CRL) to carry out the repairs to the ‘spalling’ concrete on the columns and soffits of the north and south approach viaducts. Michael Balletta of CRL reports.**

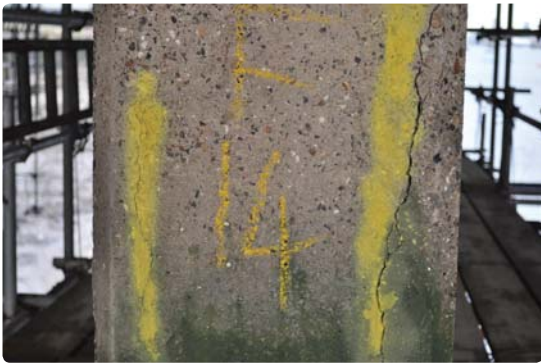
Figure 3 far left: Cracks to pile arrises along vertical reinforcement bars due to the expansive forces caused by the corrosion of the reinforcement.

arrises (see Figure 3). Some of these cracks had been noted in the 2003 survey, with the majority having increased in length, but not in width. However, a few of the larger cracks noted in the 2003 survey had increased in width to approximately 7mm. This was to be expected taking into account the severe conditions to which the piles were subjected and the fact that corrosion had probably already been initiated in 2003. A number of the cracks also exhibited signs of rust staining, indicating that the reinforcement was corroding (see Figure 4).

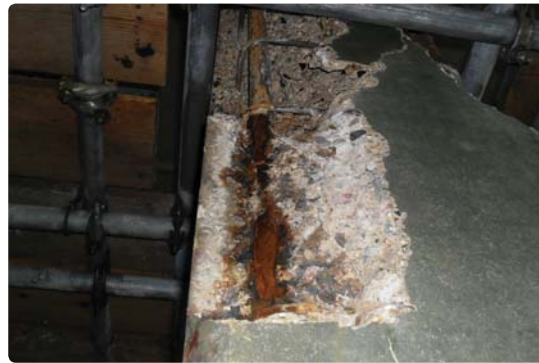
Figure 4 left: Spalled area of pile showing chloride-induced corrosion to main reinforcement bars.

As there is no record of condition testing of the concrete being carried out in both the 2003 and the 2010 surveys, it was difficult to ascertain whether the cracking to the arrises was due to the impact on the piles when they were driven in originally, whether an accelerator such as calcium chloride was used when the piles were cast (as was the norm in those days), or whether the salt water had finally worked its way through the concrete cover, destroying the passive layer around the reinforcing and allowing the corrosion process to commence.

Once the access works were in place, CRL was instructed to carry out full close-up visual inspections of the piles, as well as hammer testing of all the accessible concrete surfaces. CRL Surveys, a division of CRL, also carried out a condition survey of the piles comprising half-cell potential surveying, screening for chlorides, cover-meter surveys and the preparation and testing of concrete core samples for compressive strength and density. The results confirmed that a chloride-based accelerator had not been used at manufacturing stage; however, chloride levels of up to 3% by weight of cement were found at the depth of the reinforcement.

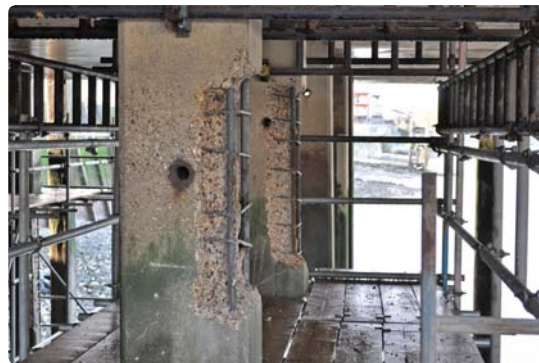
Figure 5 left: Areas of piles where loose, cracked, spalling concrete has been removed with hydro-demolition.

The specification, however, was not entirely prescriptive on the method of breaking out the loose, cracked, sub-standard concrete and getting behind the reinforcing. After carefully considering the advantages and disadvantages of mechanical methods, CRL decided to go with hydro-demolition. Its main advantages over

mechanical breakout were the easier mobilisation of the plant and equipment, resulting in more concrete being able to be broken out in a shift. The cost advantage of this method of breaking out became more evident when high tide fell in the middle of a 'daylight' shift, necessitating a mobilisation in the morning and another late in the afternoon (see Figure 5).

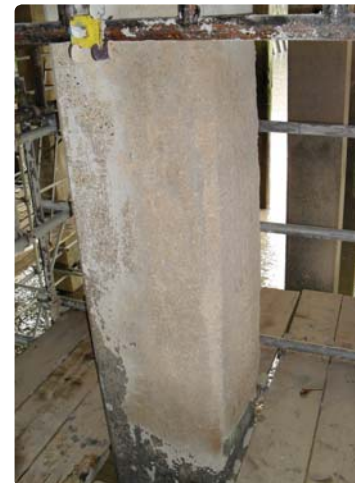
Figure 6 below: Repaired pile showing reinstatement of a patch using Natural Cement's Shotcrete 530 dry spray concrete.

Due to the tidal fluctuations, up to 7m, the material required to carry out the repairs needed to be fast setting, as well as gaining strength rapidly. After a thorough analysis of the materials specified, and what other materials were available, the decision was made to use Natural Cement's Shotcrete 530 dry spray concrete. Not only was this material fast setting and fast curing but its rapid strength gain allowed CRL to confidently reinstate the broken-out areas between tides with no possibility of the material being washed out, or in any way being compromised (Figure 6).

To slow down the rate of corrosion, and ensure the longevity of the repairs by negating the 'incipient anode effect', discussions are now being held regarding the inclusion of sacrificial galvanic anodes within the repairs, and/or the attachment of large zinc anodes externally.

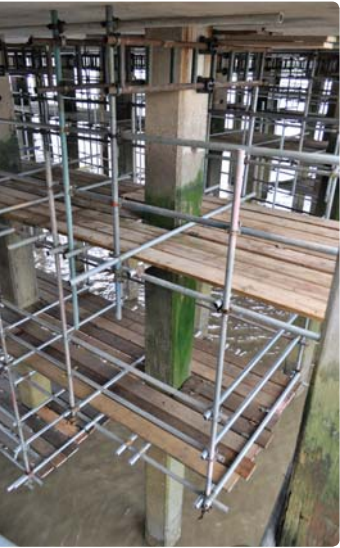
Figure 8 above: Typical access to piles (note the three lifts required to access the full height of the pile).

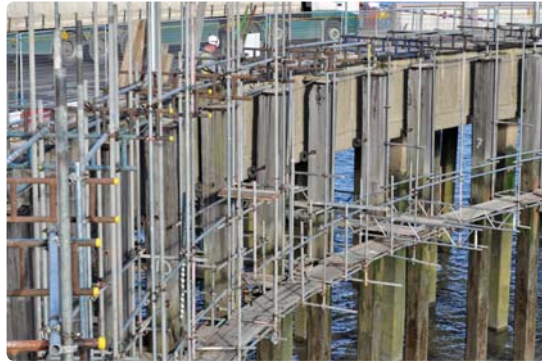
Figure 7: Initial access configuration from top of approach viaduct.

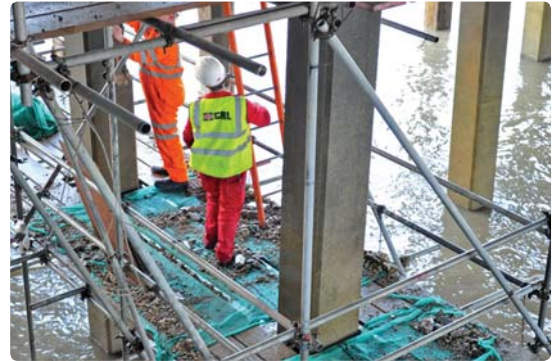
Figure 9 above: Clearing up debris after hydro-demolition and before tide rises.

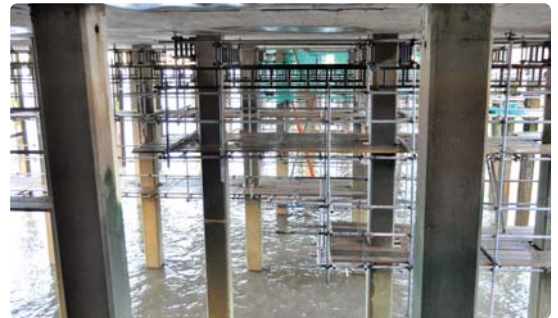
Figures 10 far right: View of cleared scaffolding/access prior to rising tide.
