FINALIST—
2020
PROJECT OF
THE YEAR

Repair and Protection of Oldbury Viaduct: the Largest Concrete Repair Project Ever in the United Kingdom

BIRMINGHAM, WEST MIDLANDS, UNITED KINGDOM

SUBMITTED BY VECTOR CORROSION TECHNOLOGIES

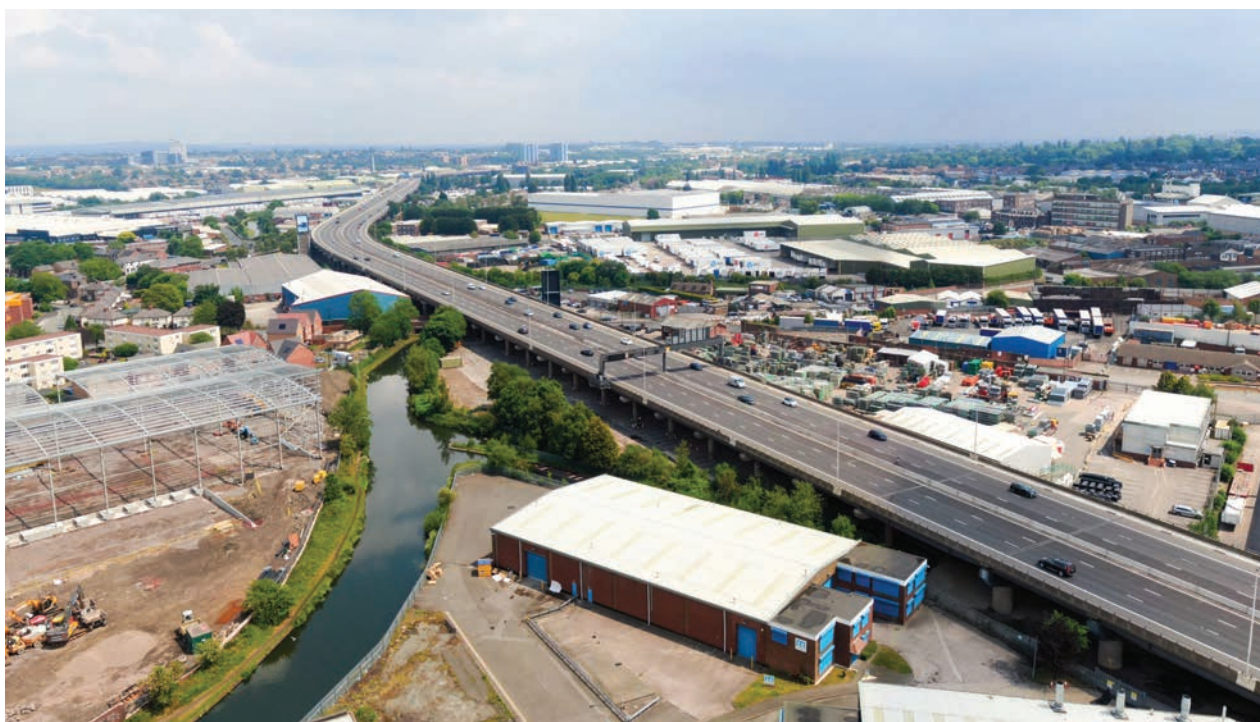
Fig. 1: Overhead view of M5 Oldbury Viaduct

At 2 miles (3.2 km) long, the Oldbury Viaduct is a major artery in the West Midlands, UK, carrying 120,000 vehicles per day (Fig. 1). There are 165 sections in the viaduct that are separated by expansion joints. After years of exposure to de-icing salts, the structure had experienced deterioration and needed major repairs. To preserve and extend its service life, a major renewal scheme was developed that included hydrodemolition, concrete repair, expansion joint replacement, cathodic protection and waterproofing. Two types of cathodic protection were employed; the substructure was protected with impressed current cathodic protection and galvanic anodes were

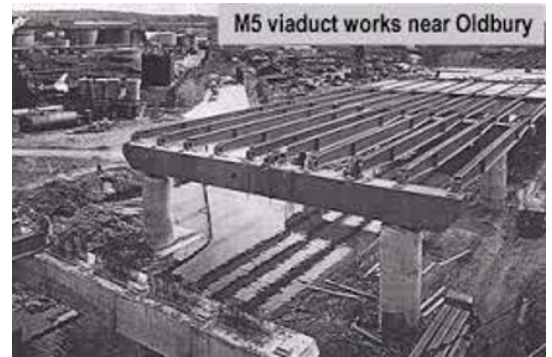
Fig. 2: Elevated construction of M5 viaduct works near Oldbury

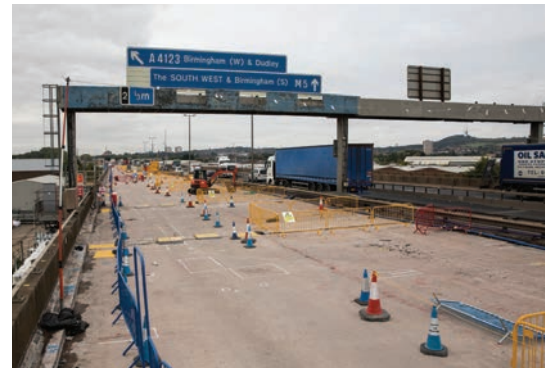
An inherent problem in the elevated sections of the motorway was that the expansion joints were directly over the bents (Fig. 3). Not uncommon, these joints leaked and allowed de-icing salts to percolate through and pond on top of the support beams. High chlorides were identified at the surface of the steel within 4 years of construction, and there were over 1,800 bents in total, supporting 13 miles (21 km) of viaduct. A comprehensive investigation was started into the extent of the problem using survey techniques that included concrete cover measurements, carbonation depths, and chloride levels and depths of penetration. In addition, half-cell corrosion potential mapping was carried out on an unprecedented scale. This information was then used to model the rate that corrosion would progress and at what point the bents would be compromised, allowing the client to know where to begin the repair. To an amateur, it might seem logical to start the rehabilitation at one end of the motorway and work along the rest of it; however, the half-cell results showed that some bents could to be left alone for many years without repair. Where there was a requirement for major repair, demolition and rebuild were considered; but even if this had been achievable, the potential disruption to the motorway network was unthinkable. A temporary solution was to install plastic guttering under the joints to divert the saline water away.

Fig. 3: Elevated sections of the motorway with expansion joints over the bents

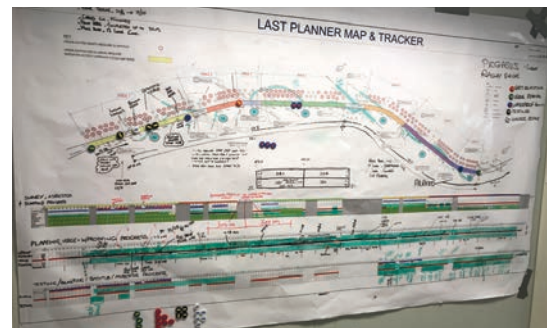
Fig. 4: Planner map for 2-year repair program

The work process started with planing off the existing surfacing and removing the failed waterproofing system (Fig. 4). A third party then tested the deck to identify where concrete repairs were needed. Hammer testing identified where the concrete had delaminated, and half-cell testing pinpointed other areas of potentially corroding steel. Once the areas requiring repair were identified, the concrete that needed repairing was saw cut before proceeding with hydrodemolition.

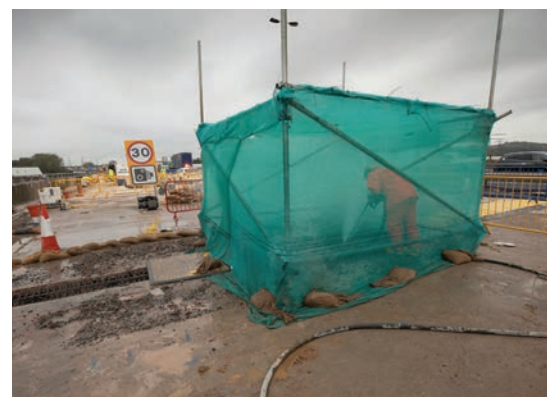
Fig. 5: Hydrodemolition of the concrete

Hydrodemolition was a crucial part of the work (Fig. 5). A 9.8 ft x 9.8 ft (3 m x 3 m) enclosure was created and surrounded with two layers of debris netting to contain flying fragments of concrete. Removing concrete with water brings safety benefits as the operators do not experience hand-arm vibration injuries and it eliminates the associated problems with silica dust. It also helps to wash away chlorides and importantly does not create vibration and microcracking in the same way percussion tools do. The water can travel at speeds of up to 1,000 mph (1,600 km/h). Due to the volume of work, the three largest hydrodemolition companies in the country at that time were all contracted to keep the project on schedule. Potable water was supplied from a complex 4 in (100 mm) pipe network on the viaduct deck. Each individual hydrodemolition team used 88 cf (2.5 m³) of water per hour.

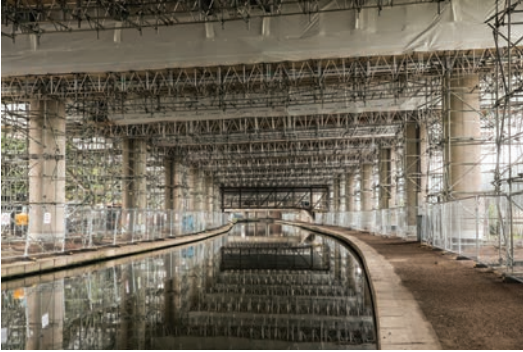
Fig. 6: Concrete repairs and installation of cathodic protection on the underside of the viaduct

Additional concrete repairs and impressed current cathodic protection were installed on the underside of the viaduct requiring one of Europe’s largest scaffold plans (Fig. 6). The scaffold also supported the network of pipes and drains required for the wastewater filtration settlement tanks. The tanks capture sediment and bubble CO₂ through the water to achieve a pH level approved by the Environment Agency, allowing it to be discharged into the adjacent rivers and canals.

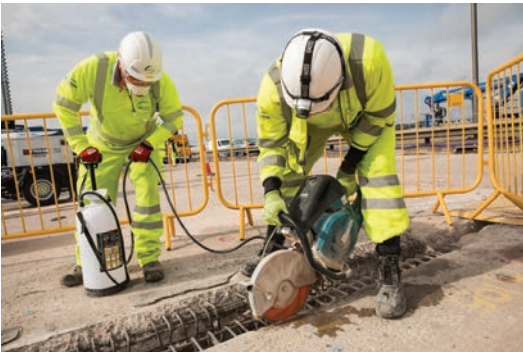
Fig. 7: Saw-cutting edges for concrete repair

Once the hydrodemolition was completed, each area was prepared for concrete repair (Fig. 7) and severely corroded reinforcement steel was replaced and welded into position (Fig. 8). At that point, alkali-activated embedded galvanic anodes (Fig. 9) were tied to the steel around the periphery of all repair areas to prevent incipient anode formation.

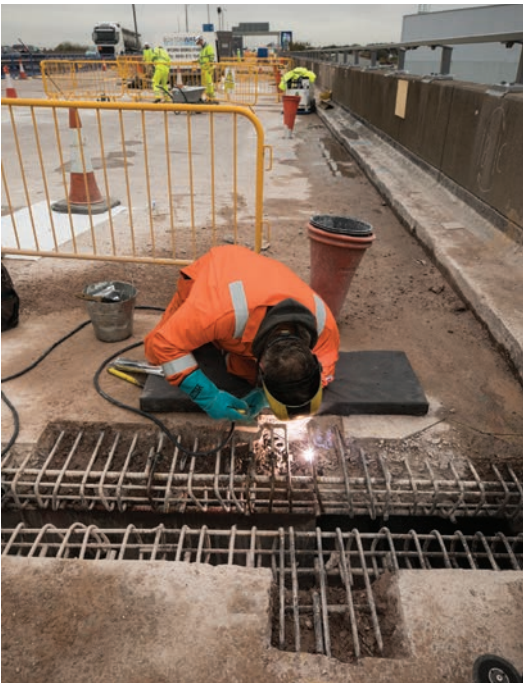
Fig. 8: Welding in new reinforcement steel

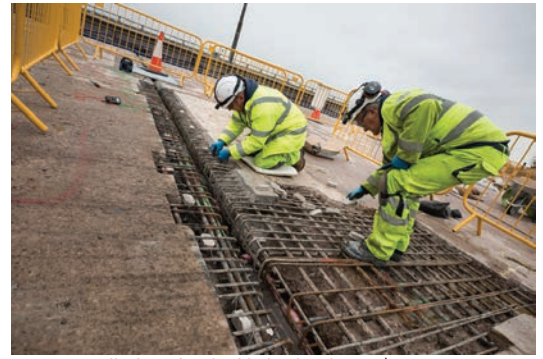
Fig. 9: Installation of embedded galvanic anodes

Considering the major investment in extending the life of Oldbury Viaduct, the risk of incipient anode formation needed to be addressed. On the substructure, impressed current cathodic protection was utilized. On the deck, embedded galvanic anodes were installed in the repair areas. The original 1990s development of embedded galvanic anodes that took place in the United Kingdom not far from this location had become a useful tool for Highways England to address localized corrosion risk. The zinc core of the anode is surrounded with a highly alkaline covering that keeps the zinc active but is not corrosive to reinforcing steel. The embedded anodes were tied directly to the exposed reinforcing steel at the interface between new and old concrete at a spacing of 18 in (450 mm).

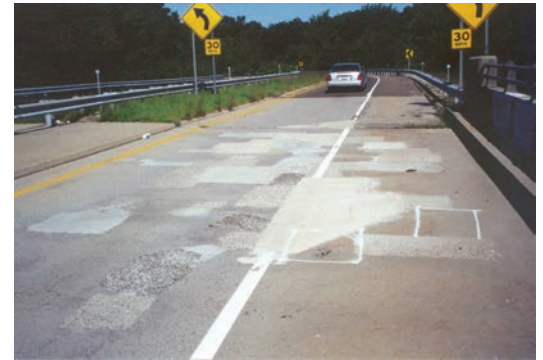
Experience has shown that repairs to chloride contaminated concrete can cause corrosion cells to propagate around the repair area in the adjacent existing concrete (Fig. 10). The steel corrodes and expands causing disruption to the waterproofing membrane, and even though it is buried beneath the tarmac (bituminous surface), it is no longer watertight. Once the water gets in, the weight from the wheels of thousands of vehicles starts a hydraulic pumping pressure to create more damage and substrate weakness. From that deterioration, a pothole in the tarmac starts to grow. Once the pothole is large enough, traffic management must be put in place to carry out what is essentially a holding repair.

Fig. 10: Example of incipient anode formation
