# Oldbury Viaduct major renewal scheme

*The £100m+ Oldbury Viaduct project, located between M5 junctions 1 and 2 in Sandwell in the West Midlands is, the largest concrete repair project (by value) ever carried out in the UK. This project began in April 2017. Matt Cain and Michael Balledda of Concrete Repairs Limited (CRL) report.*

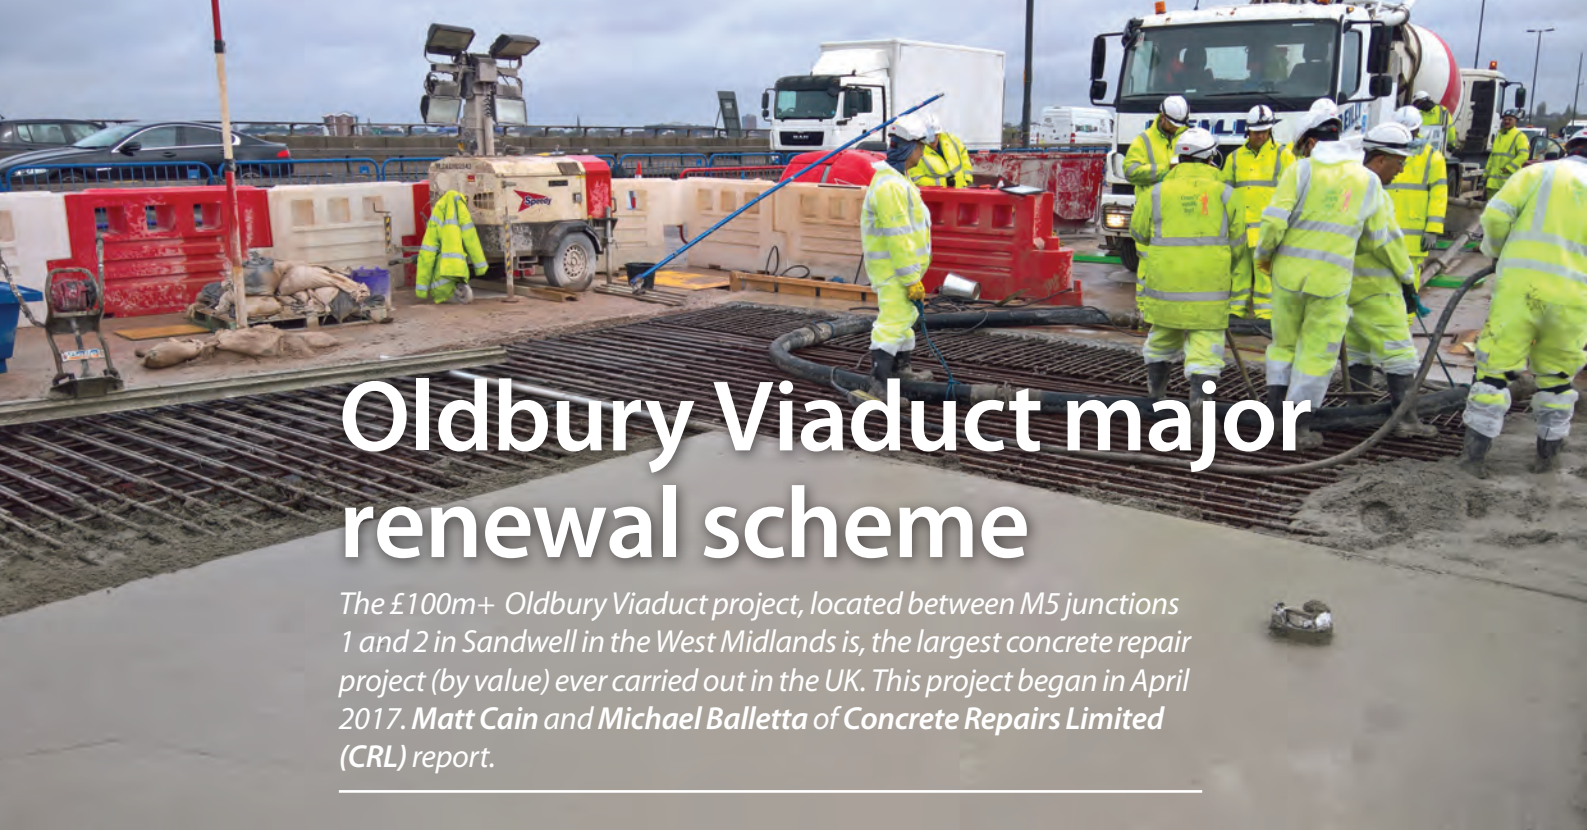
Above: Ready-mixed concrete being poured in a 200m<sup>2</sup> repair.

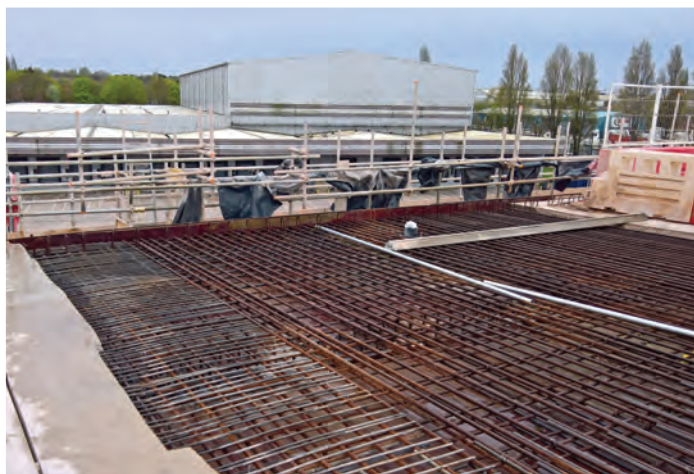
Reinforcing steel install for part of a 200m<sup>2</sup> repair.

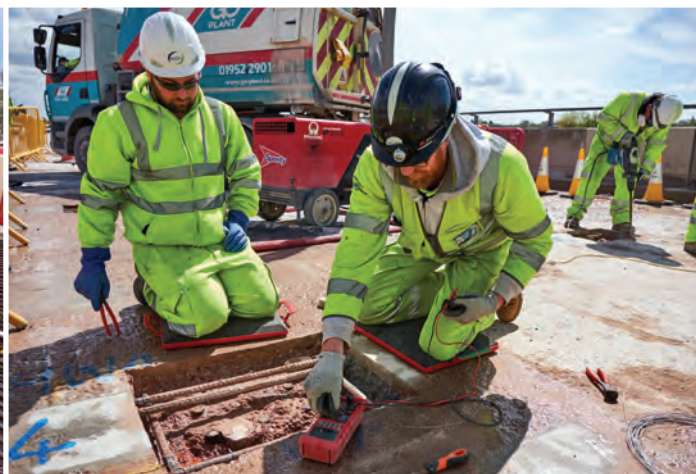
CRL's cathodic protection supervisor training an operative to carry out the continuity testing.

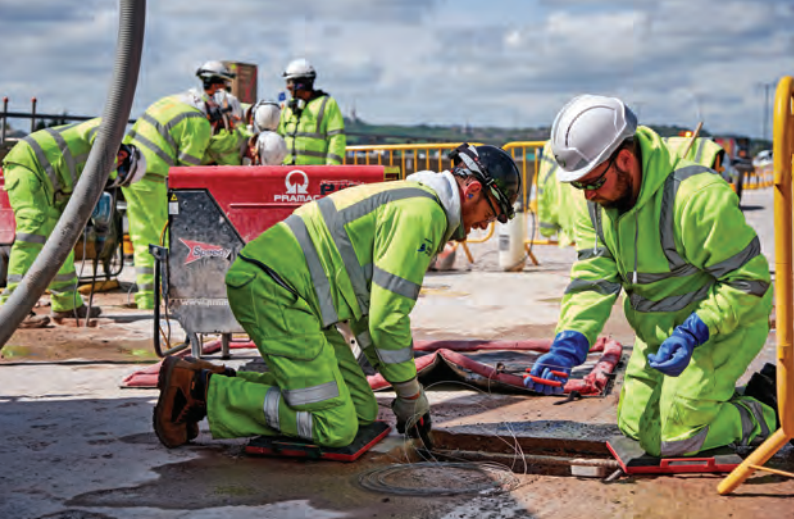
CRL's cathodic protection supervisor training an operative to install the anodes.

The next stage of the process involved replacing badly corroded steel reinforcement. A number of on-site welding devices/systems were used to connect the new to the existing reinforcement. The welds were subsequently tested using non-destructive testing methods, including magnetic particle tests and ultrasonic testing. Continuity tests were also carried out on the reinforcing steel before installation of the sacrificial anodes, which were used to prevent potential future corrosion of the reinforcement and thereby significantly extend the life of the structure. Over the course of the contract, more than 21,000 sacrificial anodes were installed.

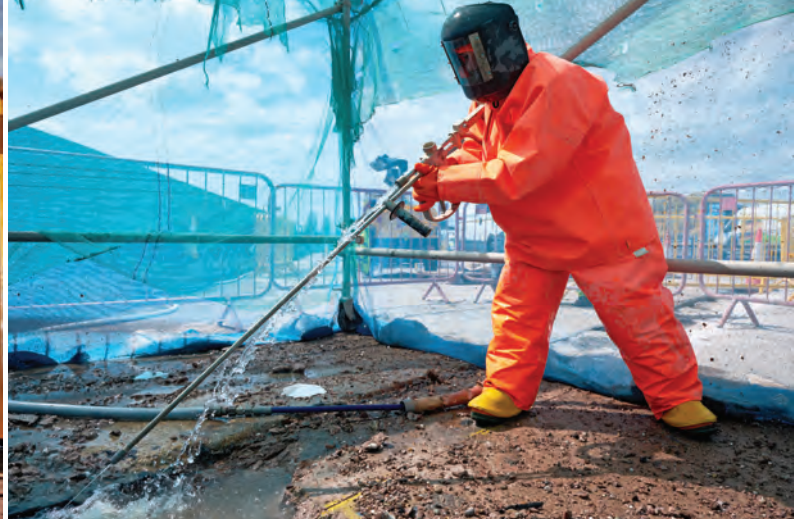
Hydro-demolition within the 3 x 3m enclosure.

Once the areas requiring repair were identified, operatives were able to saw cut around the patches that needed repairing and proceed with the hydro-demolition. A 3 x 3m enclosure was created and surrounded with two layers of debris netting to contain flying debris.

Hydro-demolition was selected as the most suitable preparatory method for both safety and efficiency, as the high-pressure water process used to remove the old concrete

and prepare the patch, exposes and cleans the existing steel reinforcement without damaging it. If traditional pneumatic breakers had been used, the reinforcing steel and surrounding concrete would have been susceptible to damage as a result of the impact and vibration created.

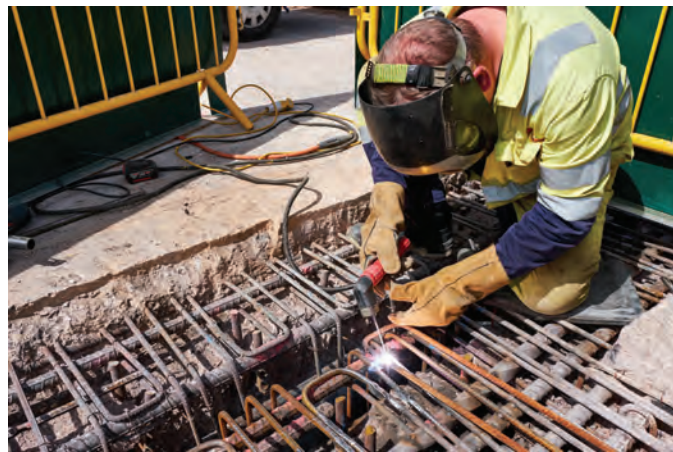
Welding in replacement reinforcing bars.
