Oldbury Viaduct major renewal scheme

The £100m+ Oldbury Viaduct project, located between M5 junctions 1 and 2 in Sandwell in the West Midlands is, the largest concrete repair project (by value) ever carried out in the UK. This project began in April 2017. Matt Cain and Michael Ballesta of Concrete Repairs Limited (CRL) report.

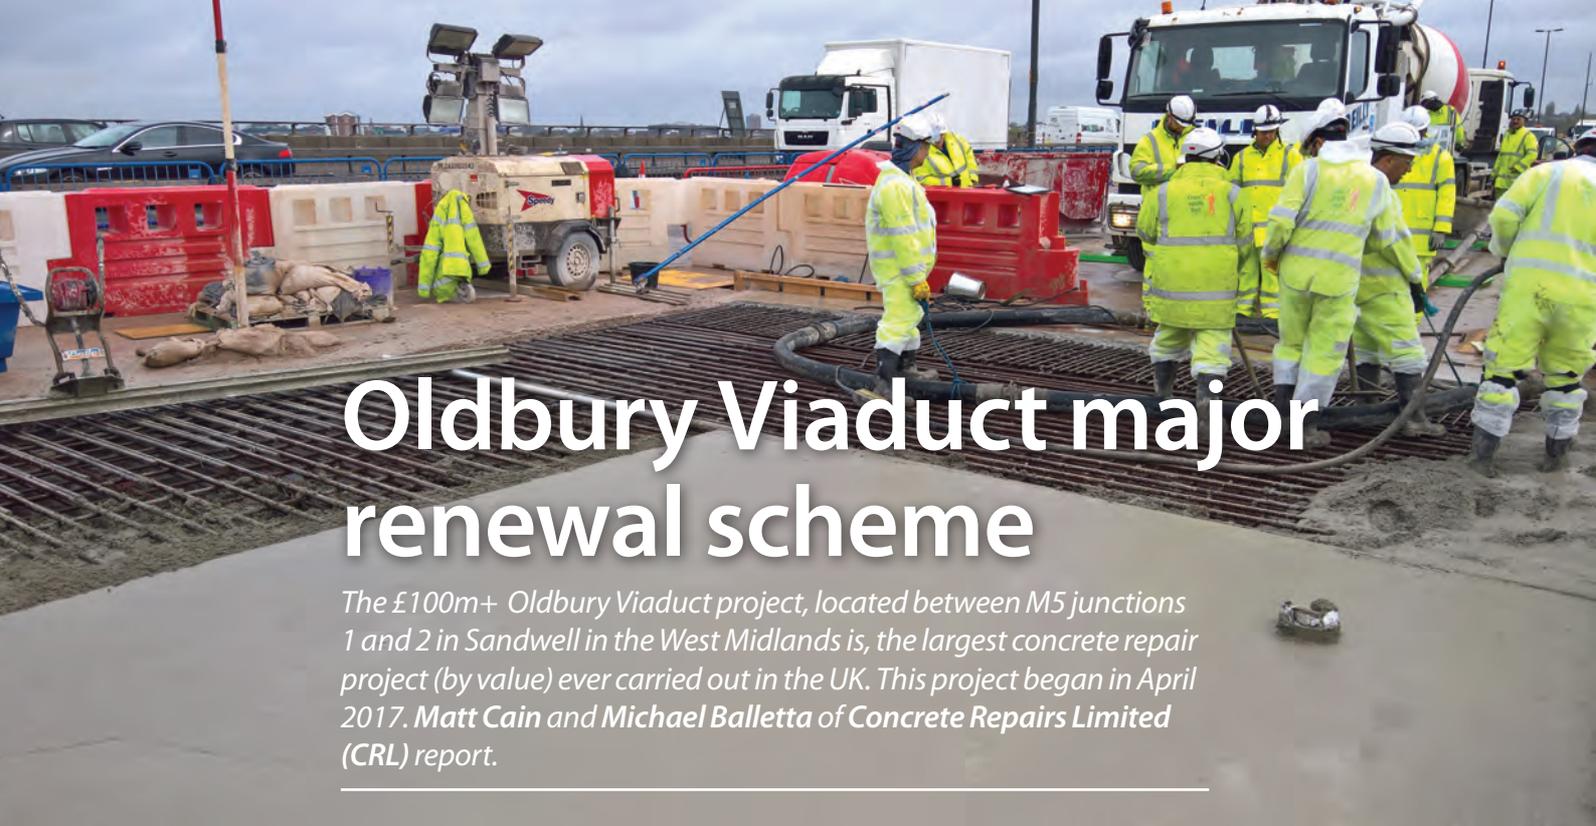
Above: Ready-mixed concrete being poured in a 200m² repair.

Once the patches had been prepared, the necessary reinforcement replaced and the sacrificial anodes installed, the broken out areas were then filled in with a high-performance, free-flowing repair micro-concrete conforming to the requirements of Highways England *Specification for Highways Works*⁽¹⁾ and EN 1504-3⁽²⁾ *Structural and non-structural repair* Concrete Class 29F. Due to the scale of the repairs, large 500kg bags of repair material were used instead of standard 25kg bags. This eliminated manual handling, as the bags were lifted using telehandlers and an opening on the bottom allowed for the material to be discharged into large pan mixers. The mixed repair material was then transferred to the individual repair areas, placed and finished by hand using trowels and floats.

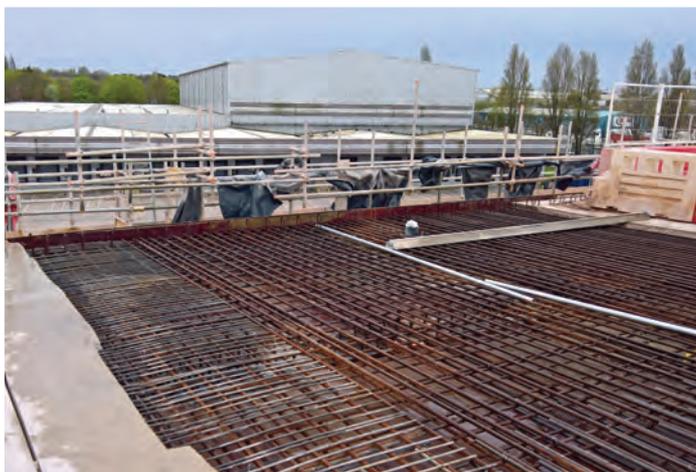
Reinforcing steel install for part of a 200m² repair.

The next stage of the process involved replacing badly corroded steel reinforcement. A number of on-site welding devices/systems were used to connect the new to the existing reinforcement. The welds were subsequently tested using non-destructive testing methods, including magnetic particle tests and ultrasonic testing. Continuity tests were also carried out on the reinforcing steel before installation of the sacrificial anodes, which were used to prevent potential future corrosion of the reinforcement and thereby significantly extend the life of the structure. Over the course of the contract, more than 21,000 sacrificial anodes were installed.

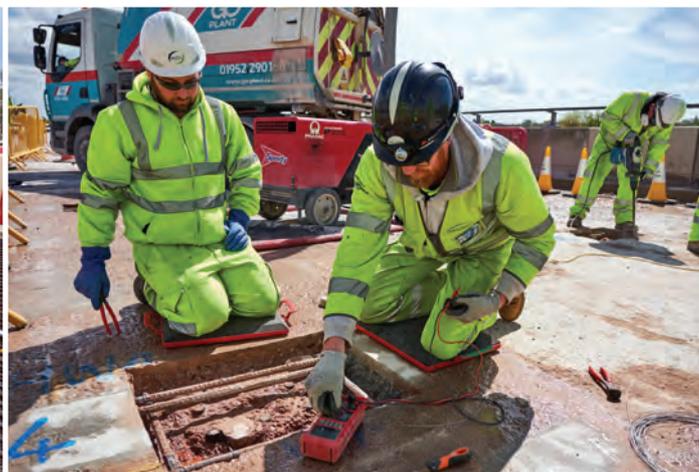
CRL's cathodic protection supervisor training an operative to carry out the continuity testing.

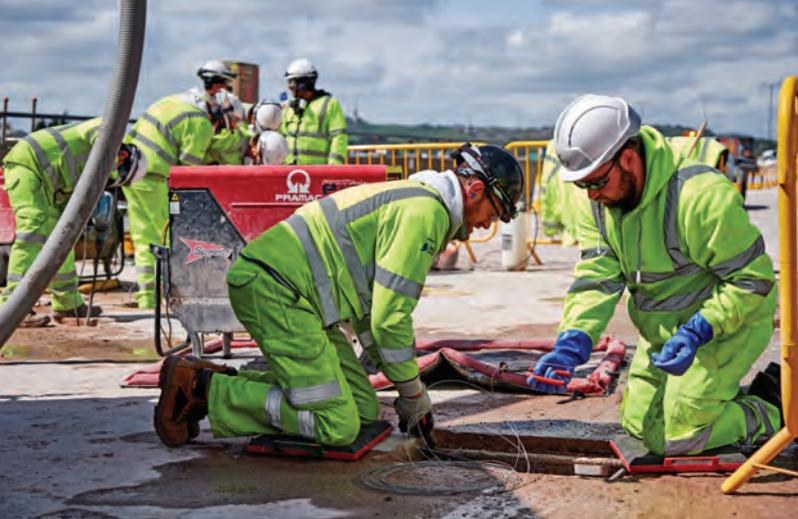
CRL's cathodic protection supervisor training an operative to install the anodes.

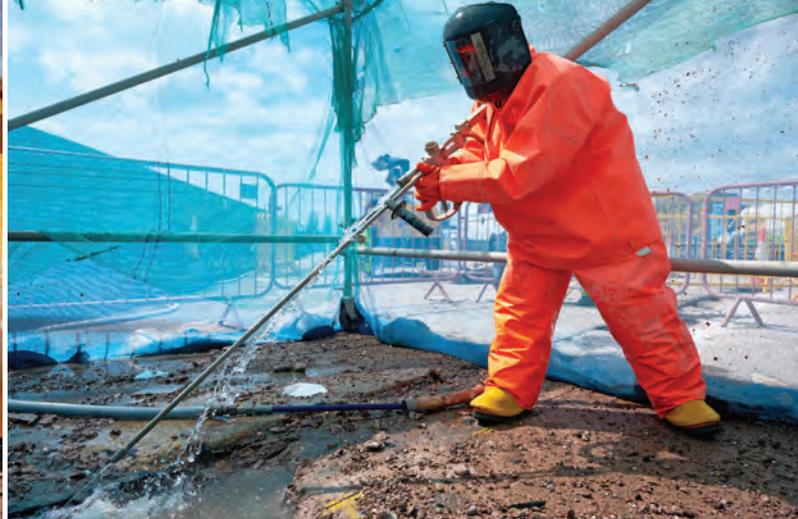
Hydro-demolition within the 3 x 3m enclosure.

Once the areas requiring repair were identified, operatives were able to saw cut around the patches that needed repairing and proceed with the hydro-demolition. A 3 x 3m enclosure was created and surrounded with two layers of debris netting to contain flying debris.

Hydro-demolition was selected as the most suitable preparatory method for both safety and efficiency, as the high-pressure water process used to remove the old concrete

and prepare the patch, exposes and cleans the existing steel reinforcement without damaging it. If traditional pneumatic breakers had been used, the reinforcing steel and surrounding concrete would have been susceptible to damage as a result of the impact and vibration created.

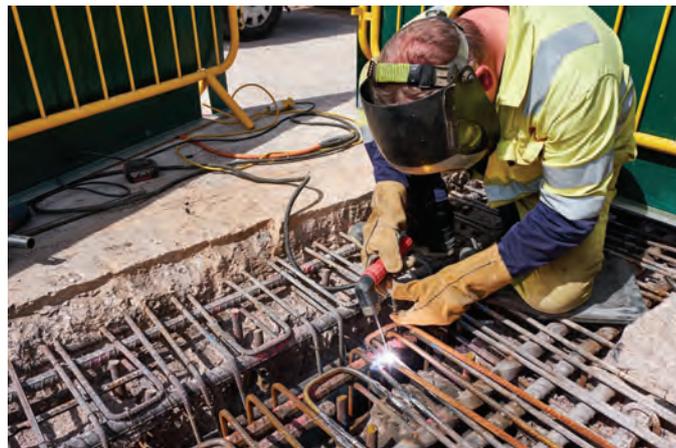
Welding in replacement reinforcing bars.
