FITTING ANODES HELPS STALL STEEL CORROSION IN CONCRETE

With steel-framed buildings of the past century vulnerable to corrosion, the installation of hybrid anodes in a recently listed car park and castle shows how structures can be effectively preserved

RICS Built Environment Journal

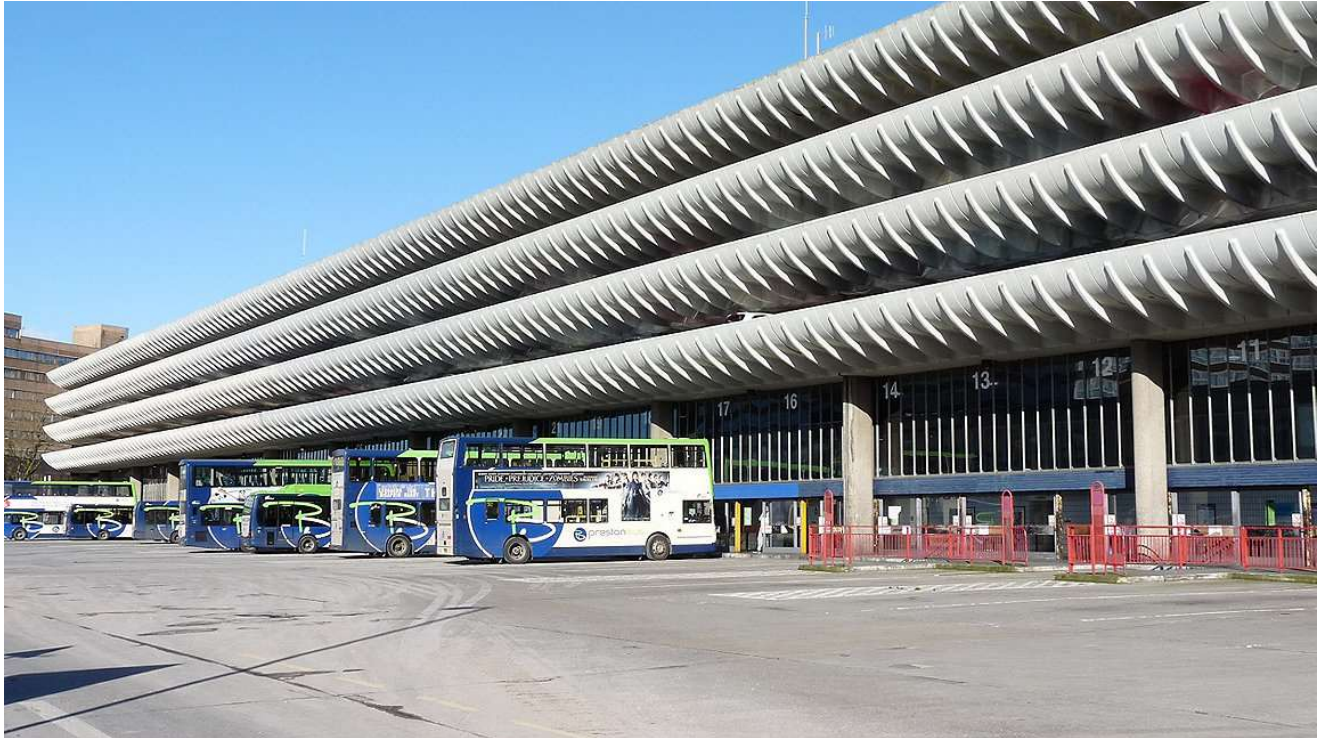
Preston bus station multi-storey car park contains steel at risk of corrosion © CPT

In the North West of England, Preston bus station's multi-storey car park was at risk due to contamination of reinforced concrete elements by salt used to de-ice roads, while in the North East, Bamburgh Castle was

When Concrete Preservation Technologies (CPT) was asked to inspect the structure, the corrosion issues were clear, with the many patch repairs and spalls due to salt ingress leading to corrosion which expands to crack the concrete.

CPT decided to protect the high-risk areas with DuoGuard, while patch repairs in lower-risk areas were to be protected from the incipient anode effect by the installation of PatchGuard.

DuoGuard is a hybrid anode system installed into 30mm-wide holes in the car park deck. Initially, the anodes used an external power source for around a week to pass large currents and halt all ongoing corrosion, then connected directly to the steel as galvanic anodes.

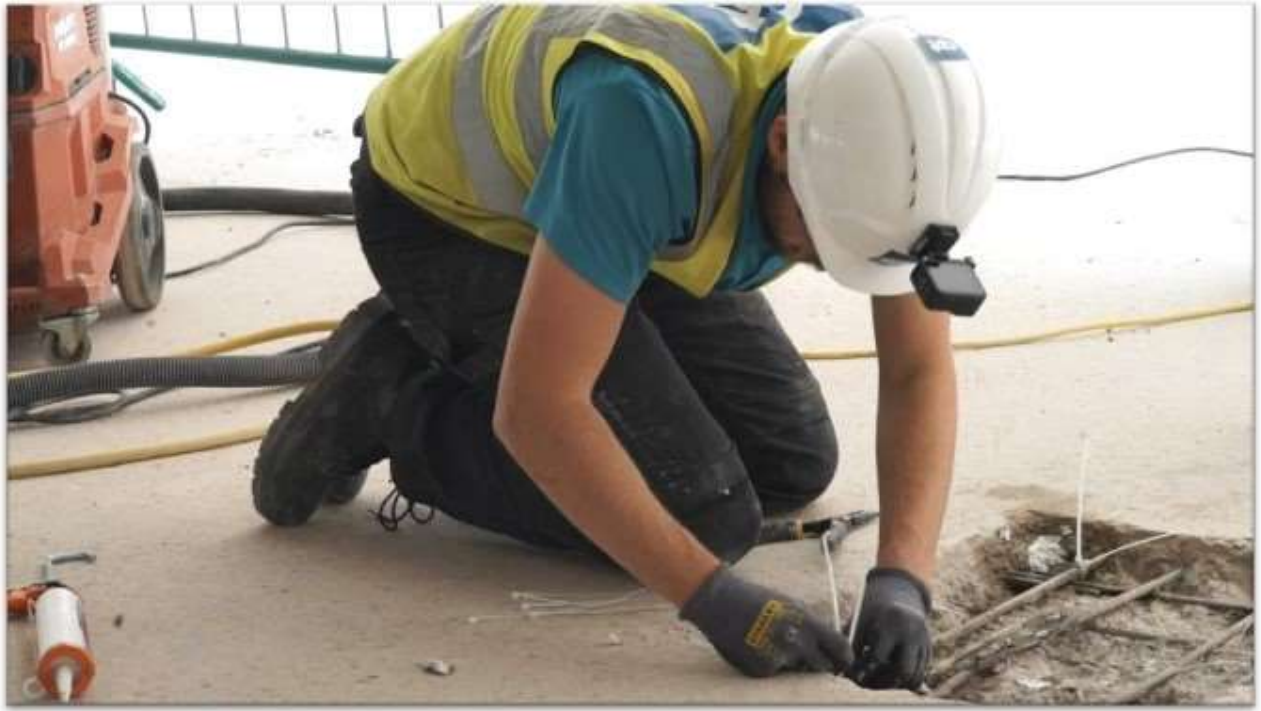
PatchGuard anode installation © CPT

PatchGuard anodes were chosen for installation around the perimeter of all patches in the concrete deck where cracking or spalling had occurred. These small anodes are installed into 25mm holes drilled in the perimeter of the patch.

Like DuoGuard, these anodes are galvanic and made from activated zinc, surrounded by a proprietary putty that keeps it wet and activated. When connected to the steel they provide a current and protect the surrounding steel. These systems also require no maintenance, allowing for the ongoing protection of the steel around the patch from corrosion for their design life.

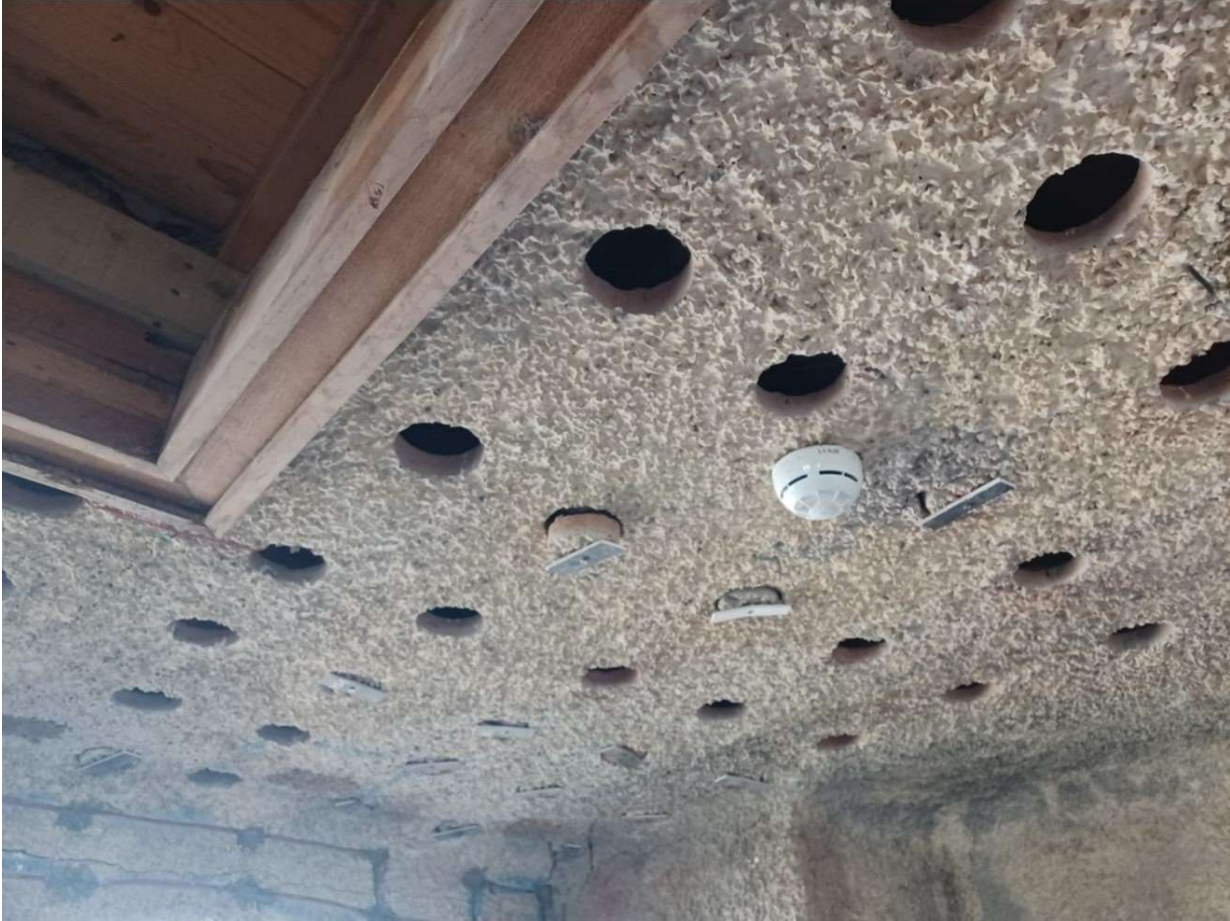
When CPT was called in to inspect the floors, we found corrosion of the steel. Because the products of corrosion expand, a management system was required to prevent damage to the structure.

Holes cored through the render and terracotta pots for anode installation © CPT

A DuoGuard system was chosen, combined with an appropriate anti-corrosion coating on the lower flange of the steel. The system features anodes of several sizes, allowing for an appropriately sized unit to be selected.

The anodes were installed through cored holes in the soffit of the terracotta and all wires were routed through the hollow formwork, reducing the need to cut chases to house them.
