BERW ROAD BRIDGE, PONTYPRIDD

Steve Jones of **Concrete Repairs Ltd (CRL)** discusses the challenging repair project to the White Bridge, a historic structure in south Wales. The bridge needed thorough structural surveying, careful gunite and reinforcement repair, and a design life extension of 50–60 years.

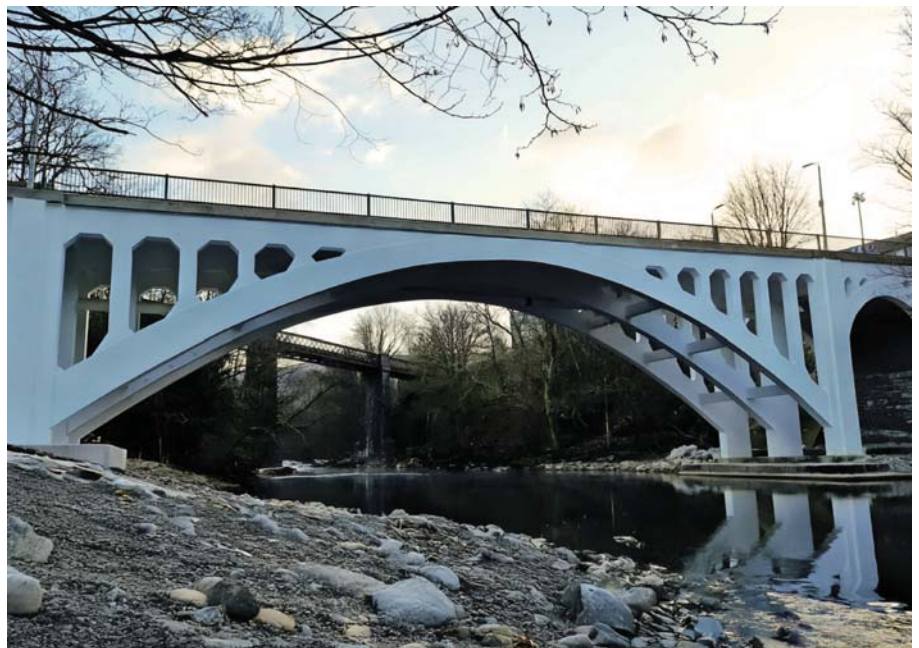
Bridge once repair works had been completed and scaffolding removed.

The repairs and new gunite were sprayed back using Fosroc DS sprayed mortar, in line with BS EN 1504⁽¹⁾. A steel trowel finish was chosen for the gunite rather than the plastic float finish that was suspected to be the method of finish on the original gunite cladding. It was a requirement that the finish had to match

the contours and angles of the structure in fine detail, with a tolerance of $\pm 5\text{mm}$. This was challenging on some elements of the structure, especially the sweeping arches, which had to continue with one unbroken run despite the works being completed in separate phases. It was a Cadw requirement that the spraying and subsequent finishing had to look as though it was all completed in one continuous run rather than a phased cycle.

Finally, the concrete structure was coated in Fosroc Dekguard A Plus anti-carbonation coating to restore the Berw Road Bridge ('White Bridge') to its original colour and former glory.
