60-YEAR-OLD MOTORWAY BRIDGE REFURBISHMENT PROJECT DELIVERED

CRL is coming to the end of a £6 million structures upgrade project on the River Dane Bridge. The 85m-long viaduct was originally constructed in 1962 and carries the M6 motorway over the River Dane between junctions 18 and 19 near Holmes Chapel in Cheshire.

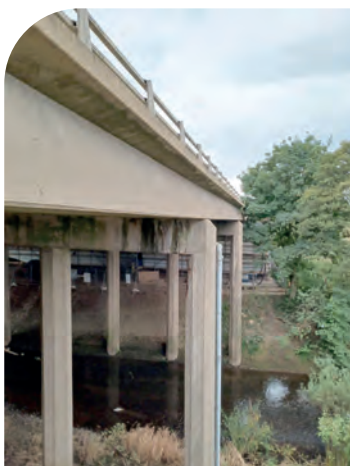
Figure 1 – River Dane Bridge before the scaffold installation.

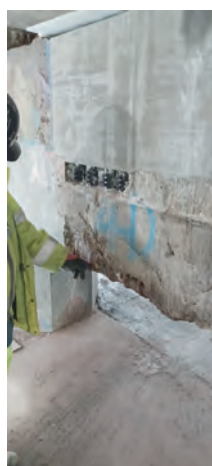
During routine inspections, it was observed that de-icing salts had migrated through the bridge joints to the underlying crosshead beams, piers and columns, and penetrated through the concrete cover causing the reinforcement to corrode. This resulted in large areas of concrete spalling, which was detrimental to the long-term structural integrity of

Figure 2 – typical areas of defective/spalling concrete.

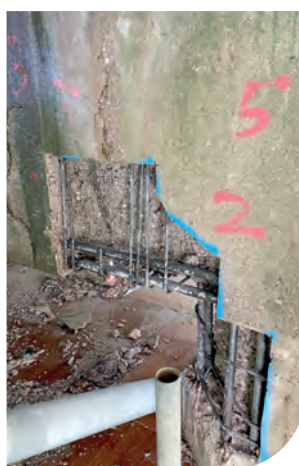
Figure 3 – defective areas prepared and ready to receive new repair material.

of all delaminated, substandard and substrength concrete and preparation of the repair areas by hydro-demolition, cleaning of the steel reinforcement (see Figures 3-5) and repairing/replacing where necessary (see Figure 6), followed by the reinstatement of the broken-out areas using Weber’s Webercem Advanced Precision Grout. An impressed current cathodic protection (ICCP) system (see Figure 7) consisting of a fabric and overlay arrangement was then installed to the crossheads and columns to protect the reinforcement in the structure and provide further corrosion prevention measures.

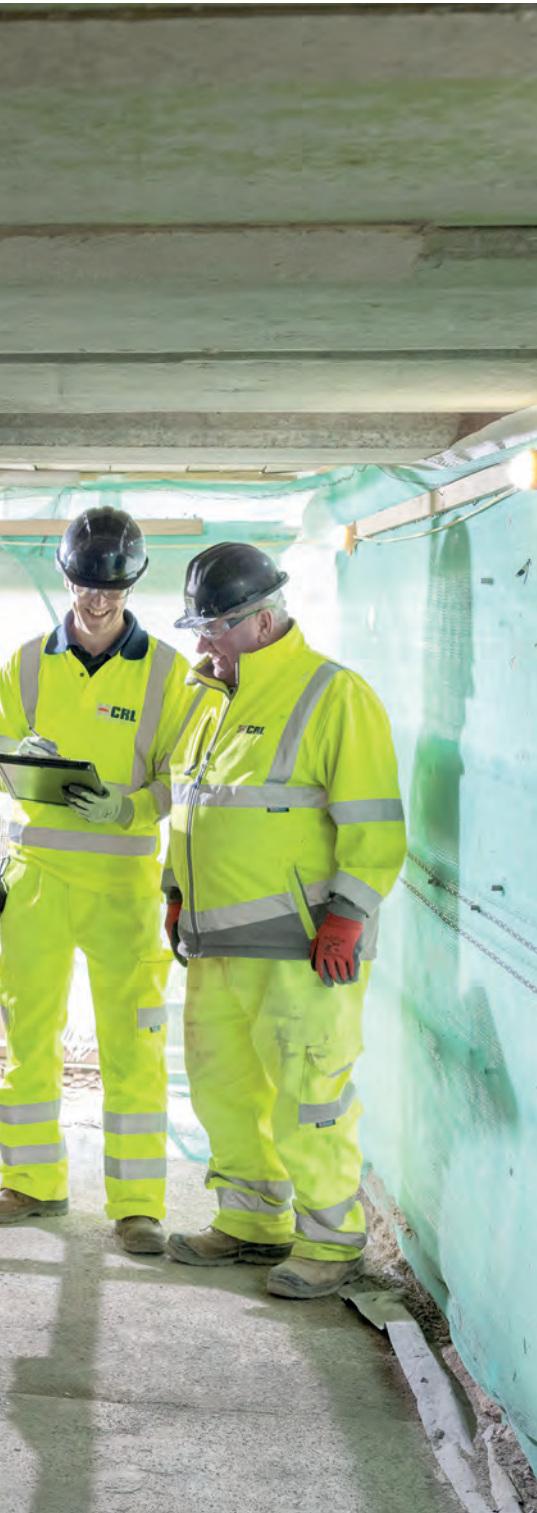
The bridge consists of a five-span simply supported beam and slab structure, with a longitudinal joint in the centre and with separate substructures on either side of that

joint. Each superstructure consists of 23 precast prestressed concrete 'I' beams and a precast reinforced concrete edge beam (see Figure 1).

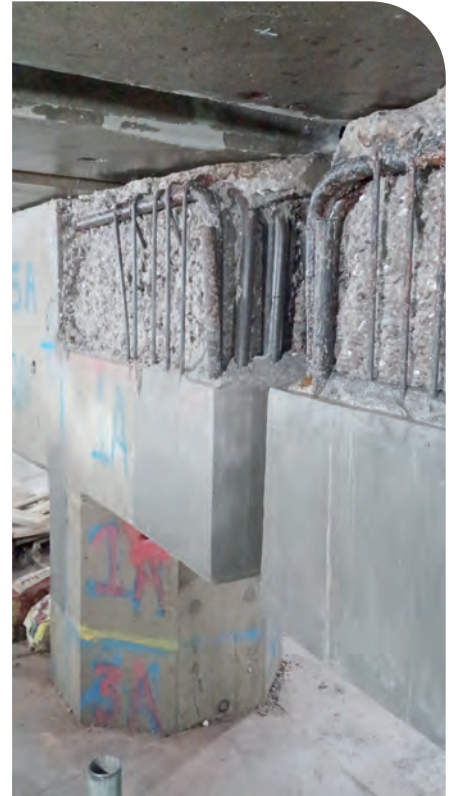
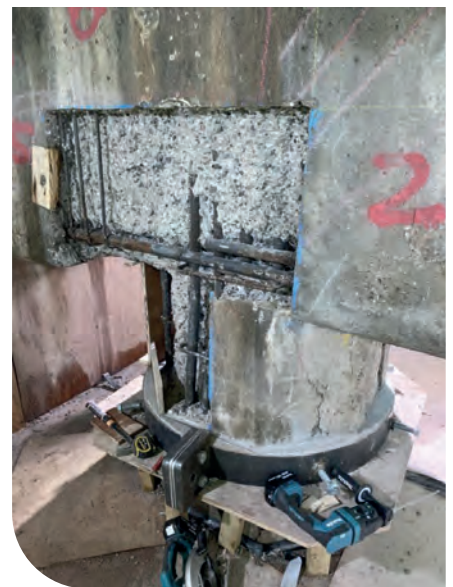
Figures 4–5 – defective areas prepared and ready to receive new repair material.

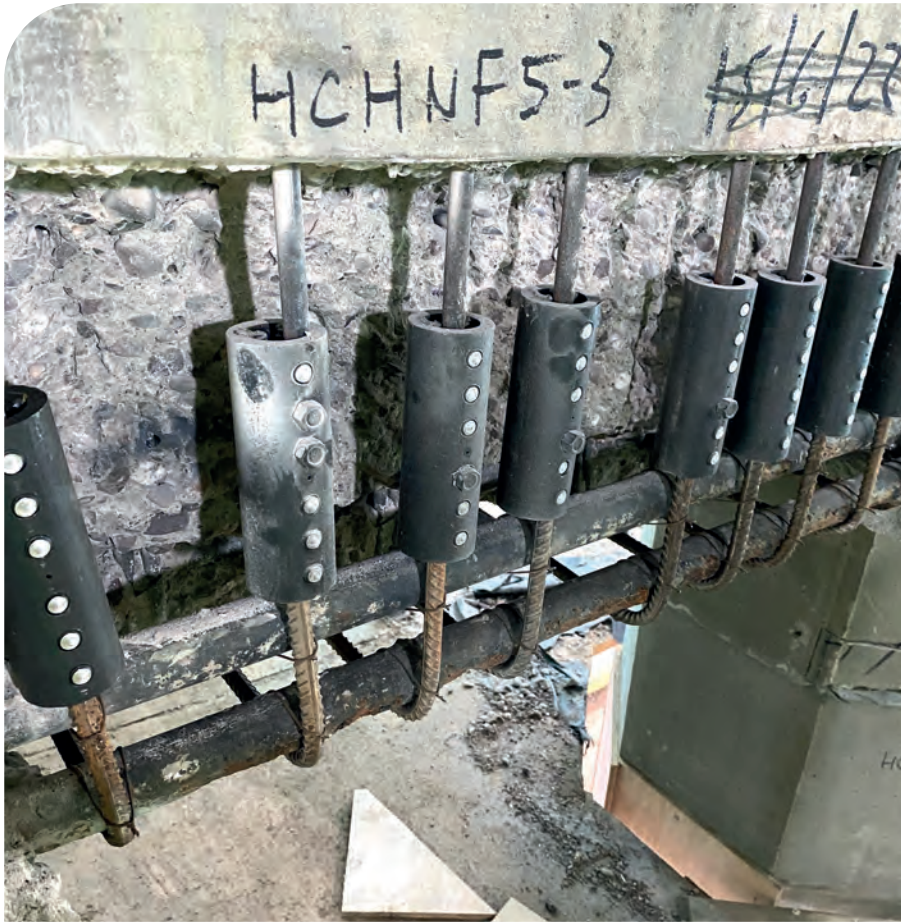
ABOVE:
Figure 6 – couplers used to connect the new/replacement reinforcing to the existing.

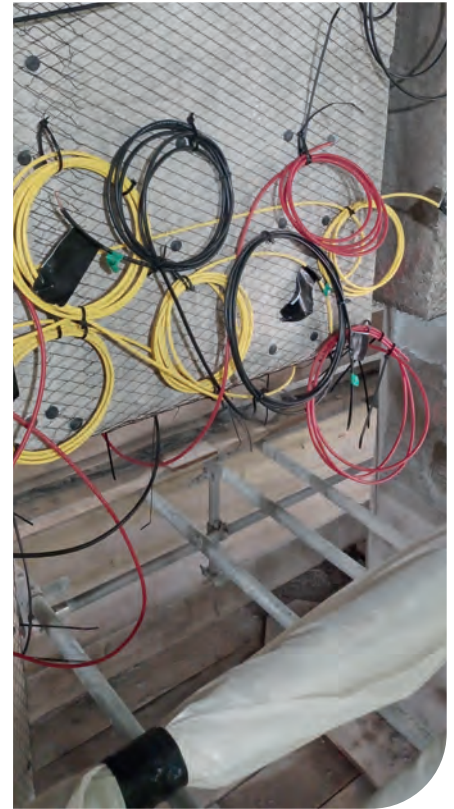
ABOVE:
Figure 7 – the impressed current (fabric and overlay) cathodic protection system.

River Dane Bridge had been subject to previous surveys and repairs over the years, and although the earlier repairs had performed well, it was decided that the installation of a cathodic protection system was now necessary to minimise future corrosion of the reinforcement and any subsequent spalling. Not only would the system save costs but also by not having to return to the bridge to carry out future repairs, there would be no need to restrict

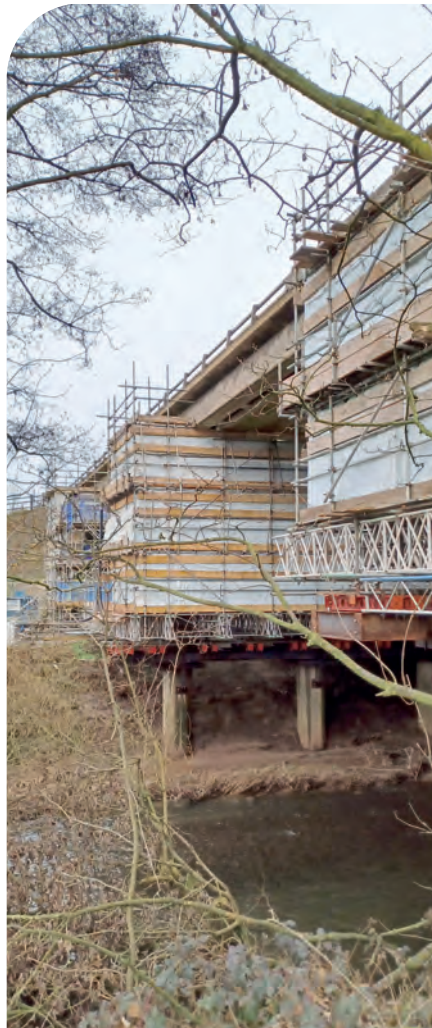
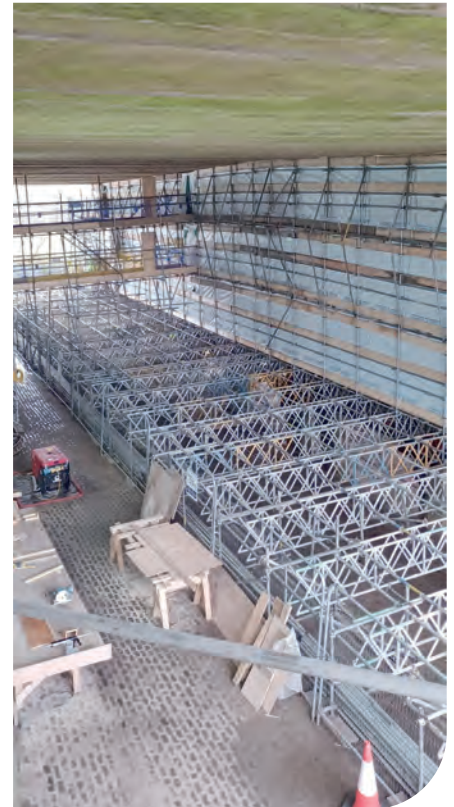
Figures 8 and 9 – the raised and sheeted access system used to stay out of the flood range.

The scaffold support steelwork comprised steel brackets, which were drilled and fixed onto the columns. A steelwork frame was then bolted onto them, thus taking the weight of the access scaffold above. This removed the need for any excavation works within the river or the motorway embankment, which would otherwise have been necessary to establish foundations for a conventional scaffold/access system. This system also had the added advantage of raising the height of the scaffold above the river water level, which avoided any potential damage during a flood event (see Figures 8 and 9).

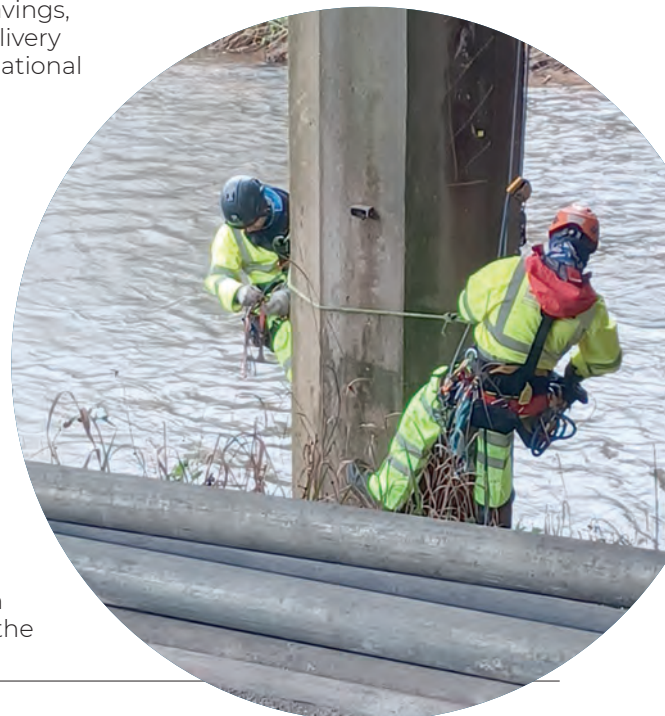
Figure 10 – delamination survey and Schmidt hammer testing being carried out to the columns
